L172000000--Marshall Co.  
Henry Public Well #3  
ILD984766394  
Vol. 1 of 2

# **CERCLA**

## **Screening Site Inspection Report**

HENRY PUBLIC  
WELL No. 3,  
HENRY, IL.

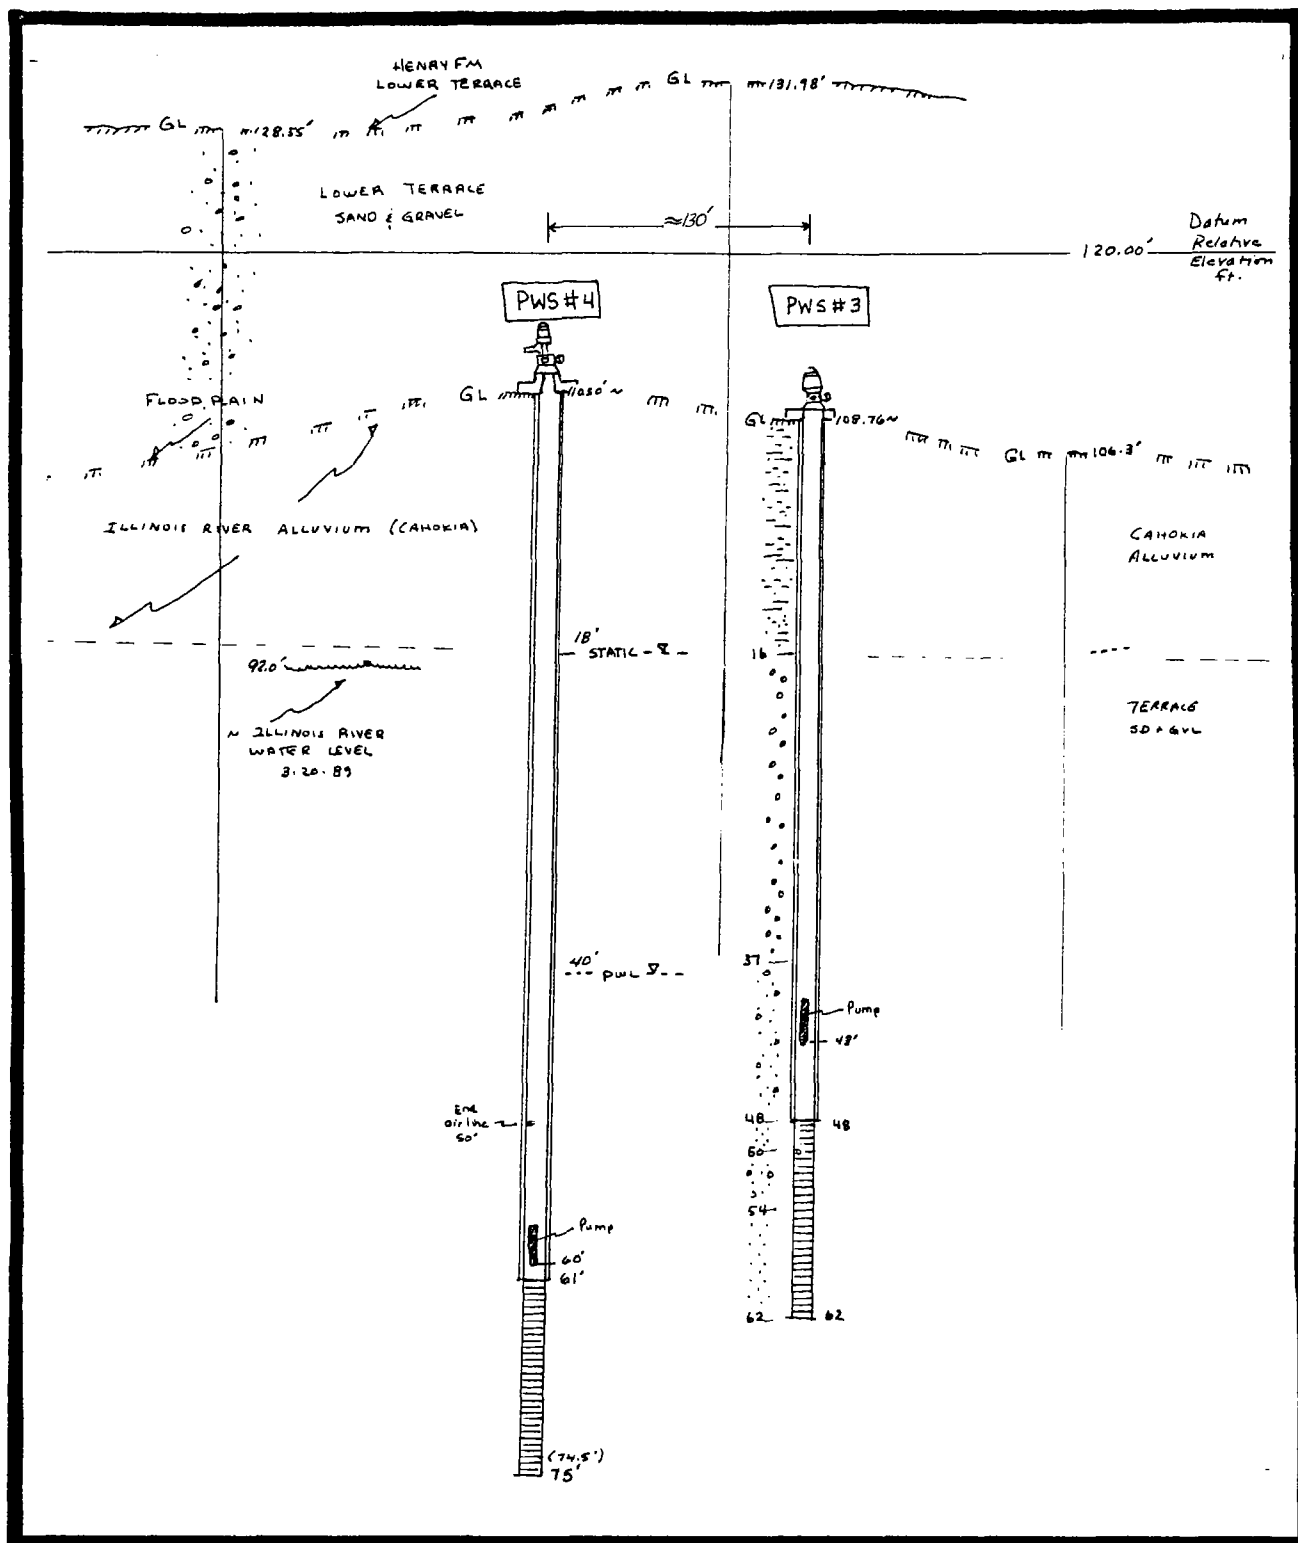
The nearest well to well #3 is Henry Well #4 which is 130 feet west and is obtaining water from the same aquifer at a depth of 75 feet below land surface. This well is screened from 61 feet to 75 feet. The Henry Public Water System serves 2,740 persons. Rural residents within the 4 mile radius of Well #3 obtain water from the same Lower Terrace sand and gravel of the

## PUBLIC WELL #3 & #4 CONFIGURATION

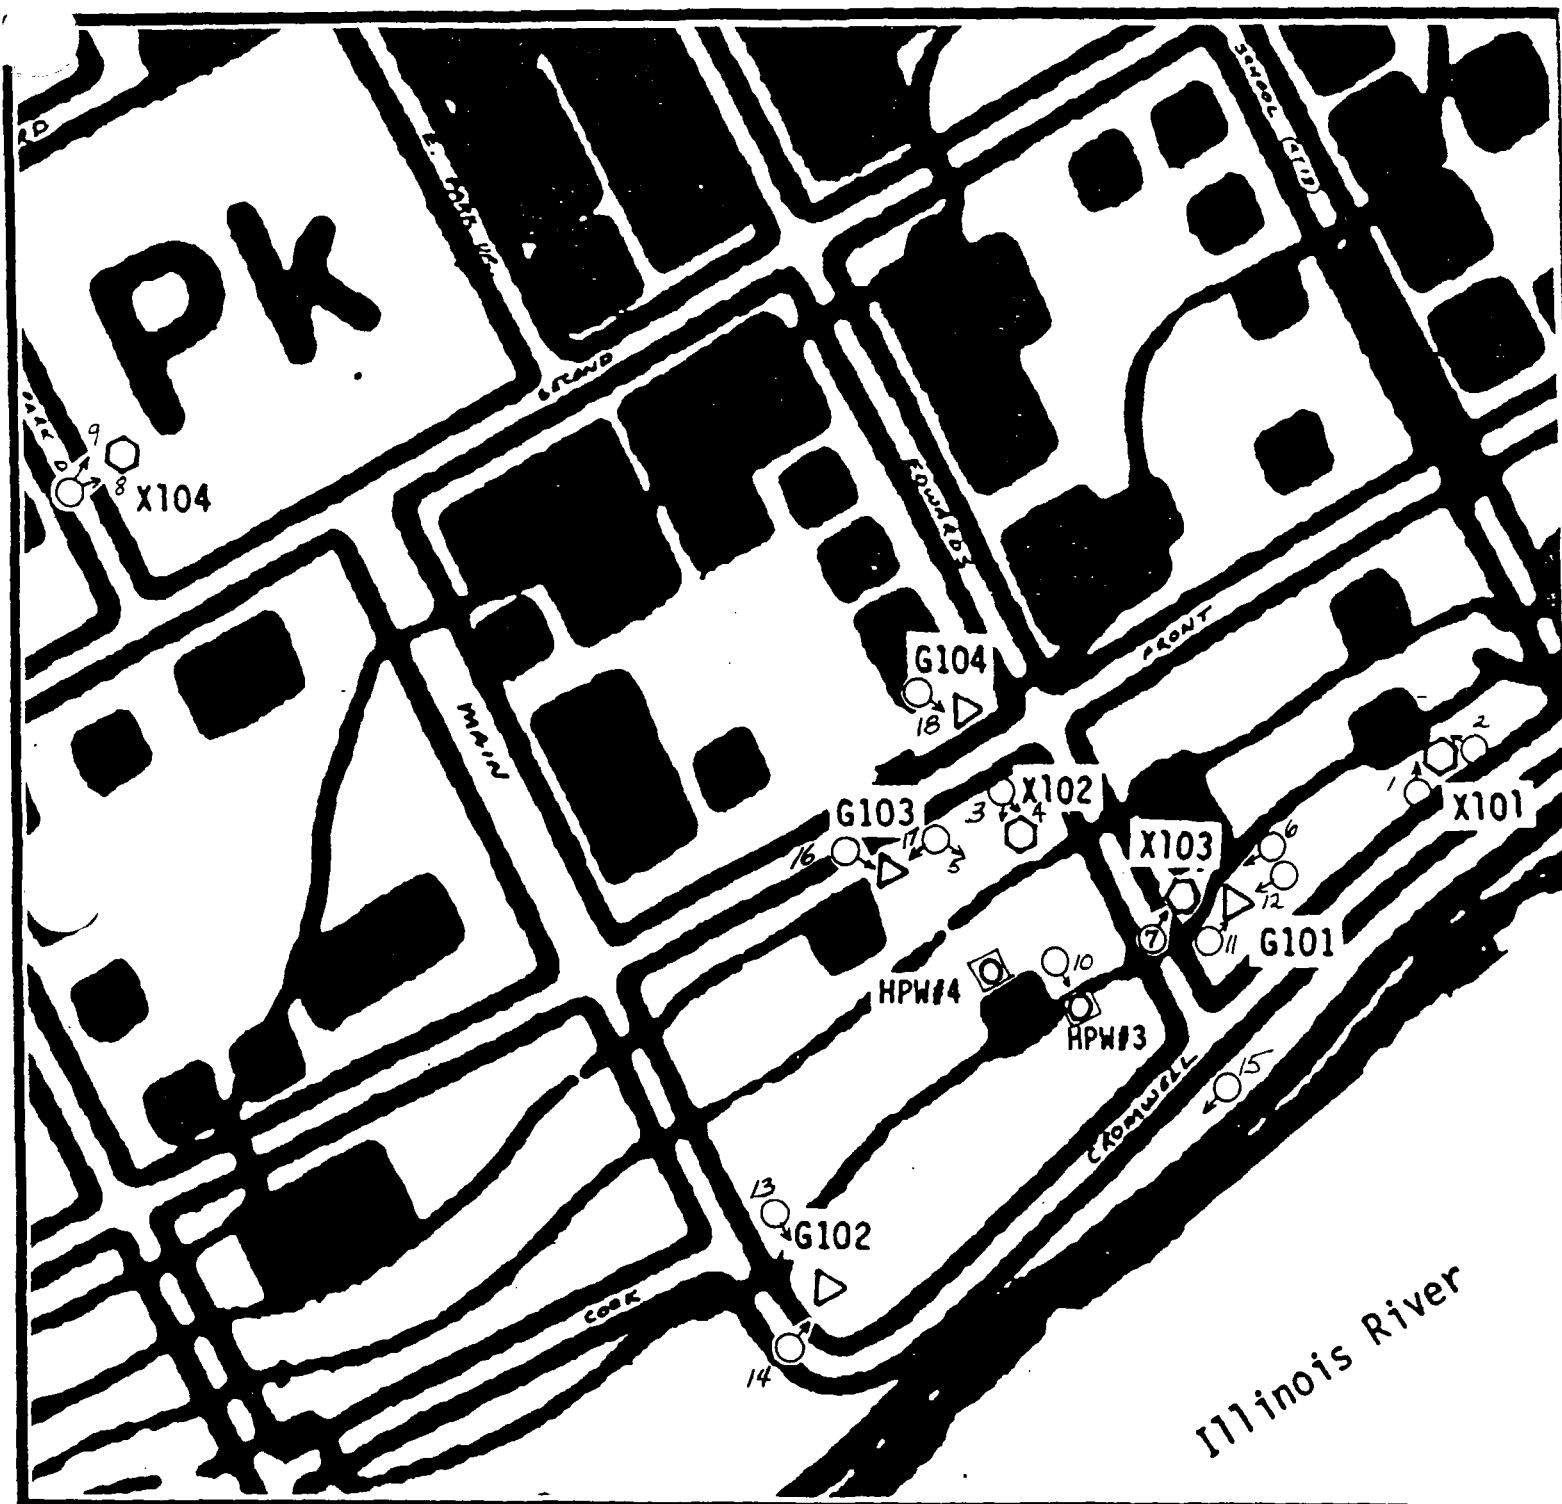
PHOTO LOCATIONS

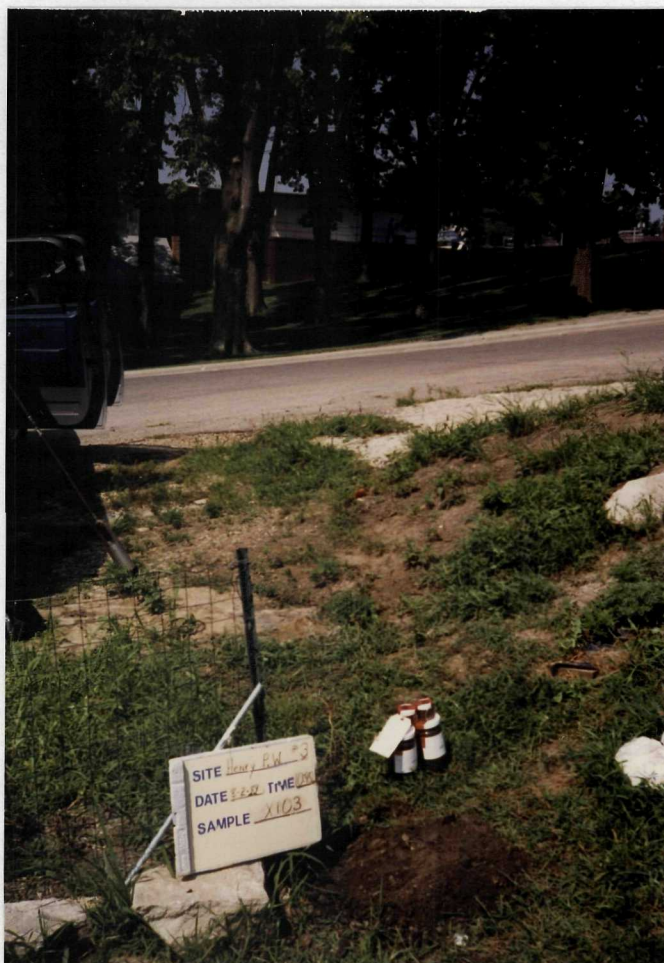
(6)

FORMER FORD DEALERSHIP

PROPERTY

may be attributed to the uses associated with the old Ford dealership (X103). Constituents found in X104 cannot be explained. It is unknown as to why these substances would be found at that location.

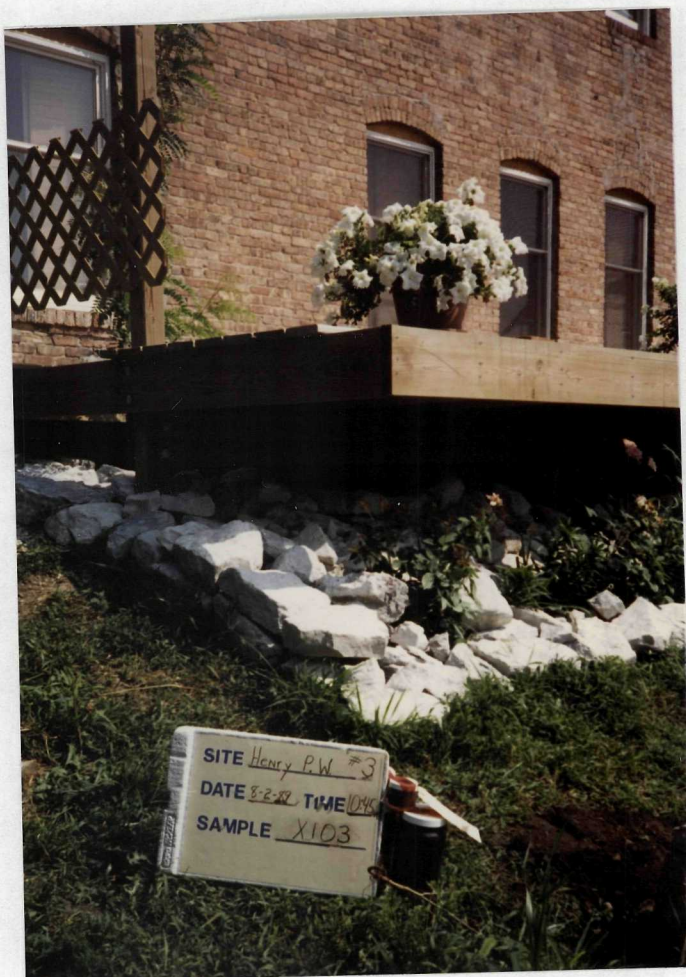
(7)

OLD FORD DEALERSHIP.
